**Flood Control Project Maintenance
Levee Inspections**
LMA District Cover Sheet
Spring 2011 Levee Inspection Results

Reclamation District No. 2031 Elliot

Spring 2011 Levee Inspection Results

Waterway	Bank	Unit Miles
Unit No. 01 Stanislaus River	Left	7.15

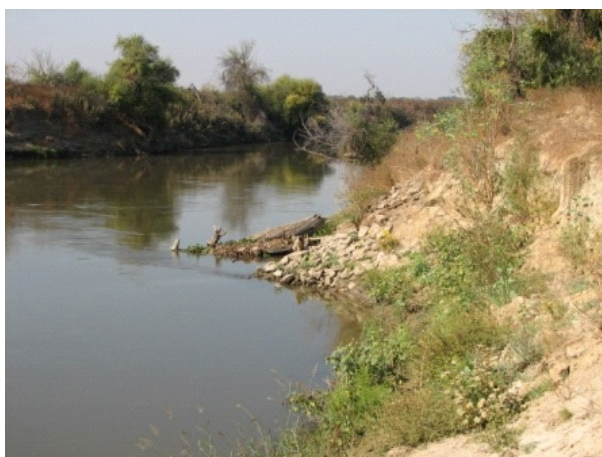
jeto_s_20110301_108.jpg

Levee Mile Report Line	11
Start Levee Mile	4.33
End Levee Mile	4.37
Location	Water Side
Category	Supplemental
Item	DWR Erosion Survey
